National Dam Safety Program.

CRYSTAL LAKE DAM

NJ00299

PHASE I INSPECTION REPORT.
NATIONAL DAM SAFETY PROGRAM

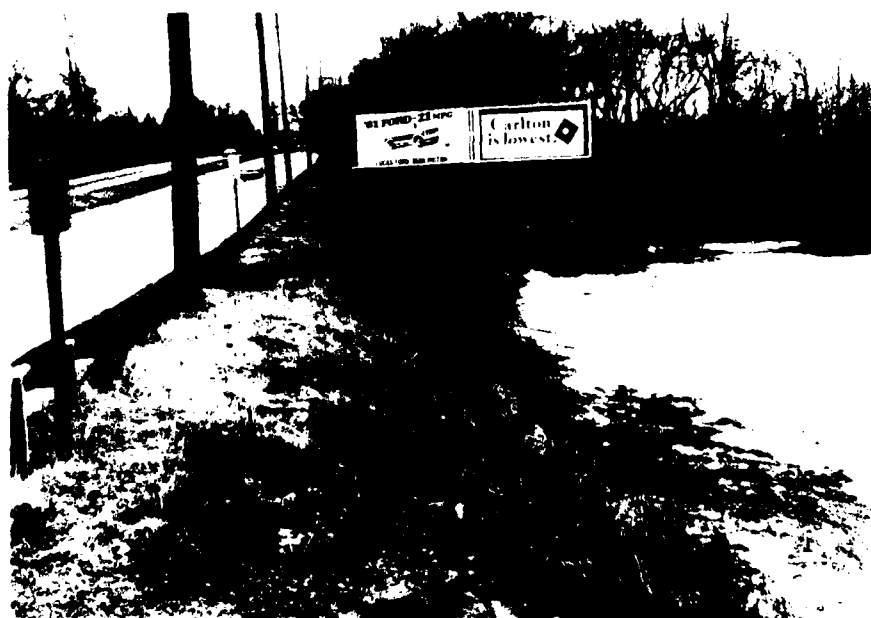
PHOTO 6
DOWNSTREAM FACE OF DAM
